# Island County Estuarine Restoration Program

**June 2001**

# ISLAND COUNTY ESTUARINE RESTORATION PROGRAM

## SWANTOWN LAKE

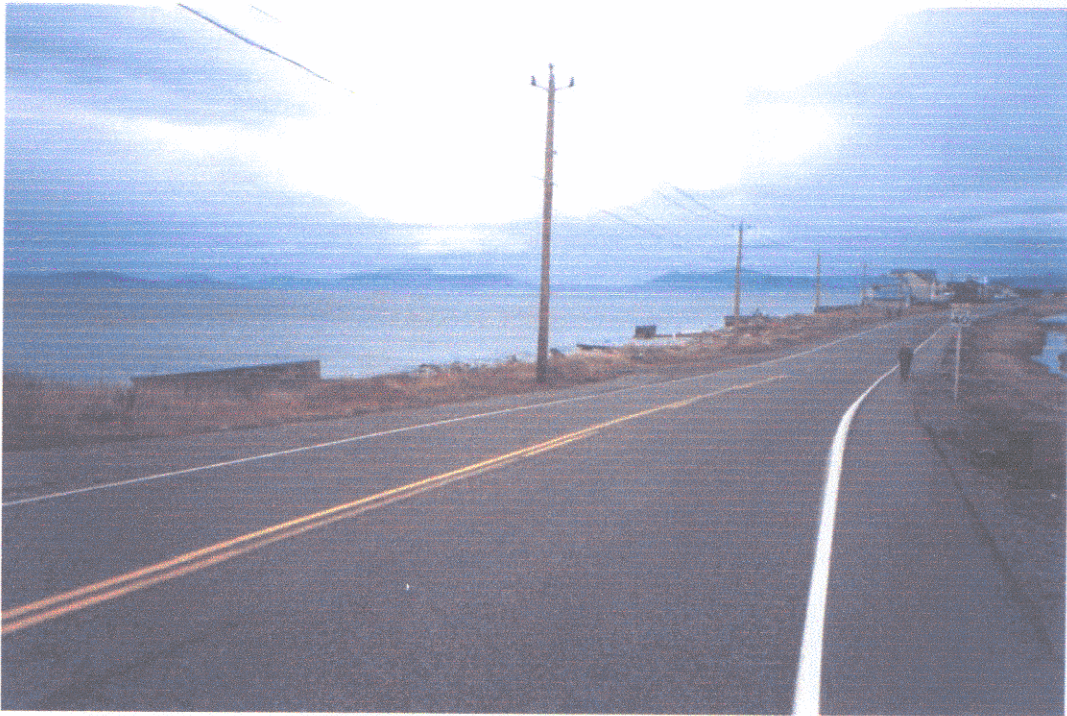
Looking north along West Beach Rd. at Strait of Juan de Fuca. Note concrete bulkheads jutting from beach.

- Under Option 2, it would be necessary to remove concrete bulkheads and footings from the beach
- Fill in ditches that parallel West Lake Road and other ditches left from farming activities/ allow tidal channels to form - Plant native tree and shrub species in the buffer of the wetland all along West Lake Road

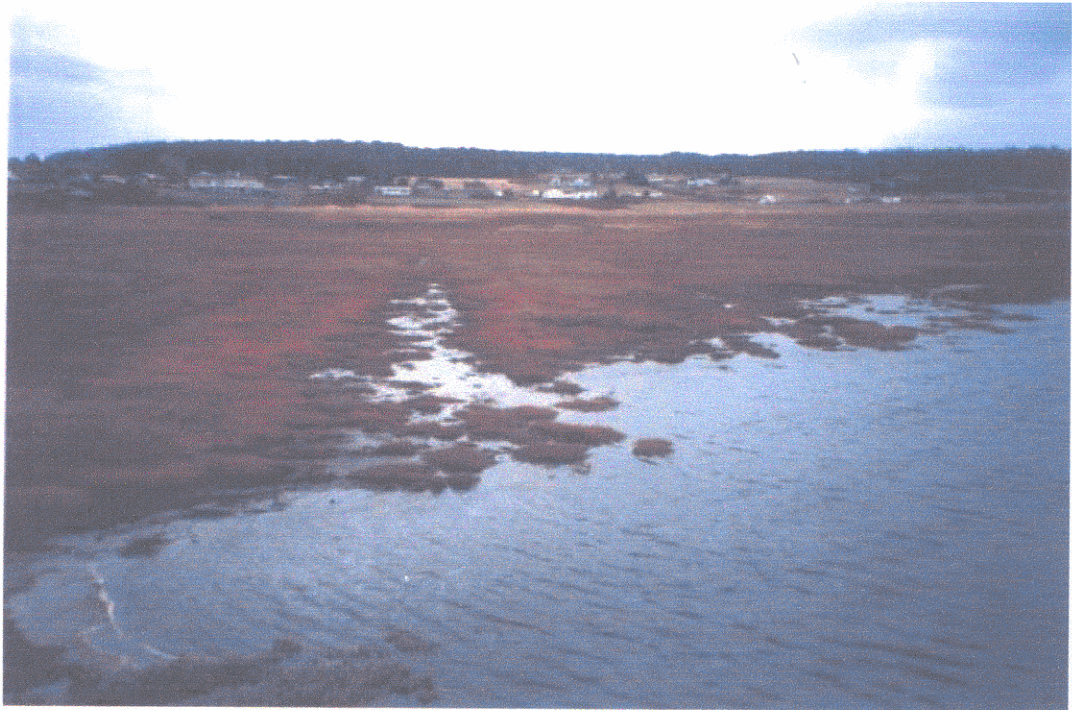
Looking east-northeast from main outlet of marsh.

Red-hued vegetation in this area indicates saltmarsh species (*Salicornia/Distichlis*).

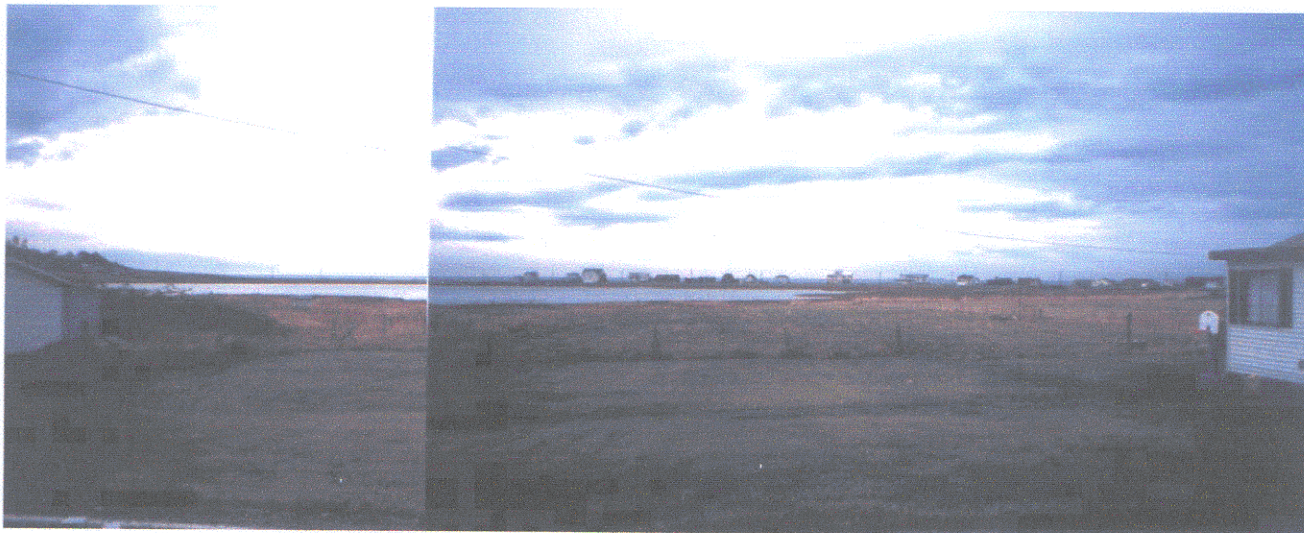
**Looking west from Swantown Road at marsh. Note potential for flooding of houses in foreground.  
Houses on beach berm are in background.**

**Concerns & Limitations:** Channel under Option 1 would be constructed in narrow area between existing houses - limits channel width. Concern for tidal surge flooding of farmed land and houses around edge of wetland. Concern for stability of West Beach Road due to peat base.

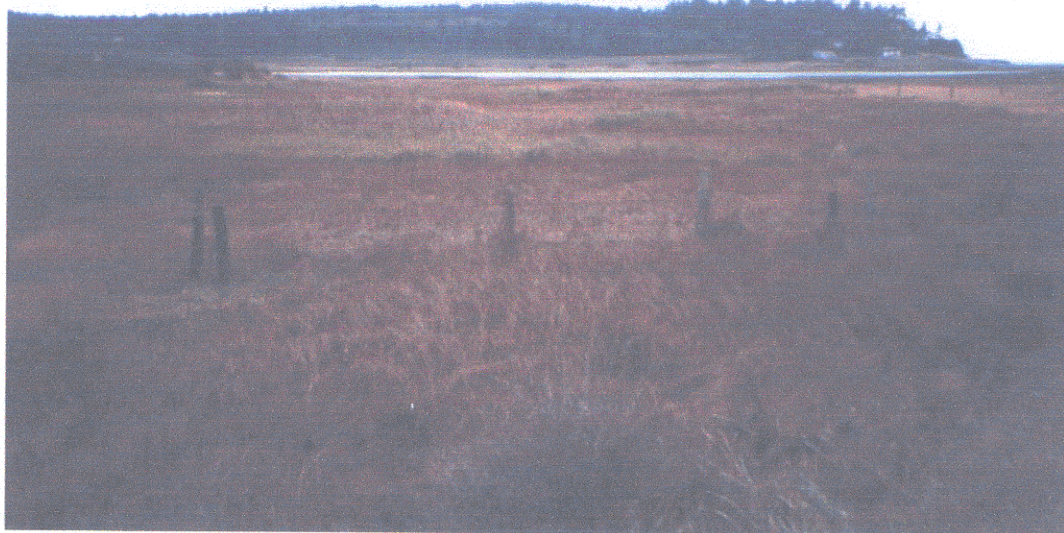
**Looking south from north end of estuary at freshwater marsh in foreground.**

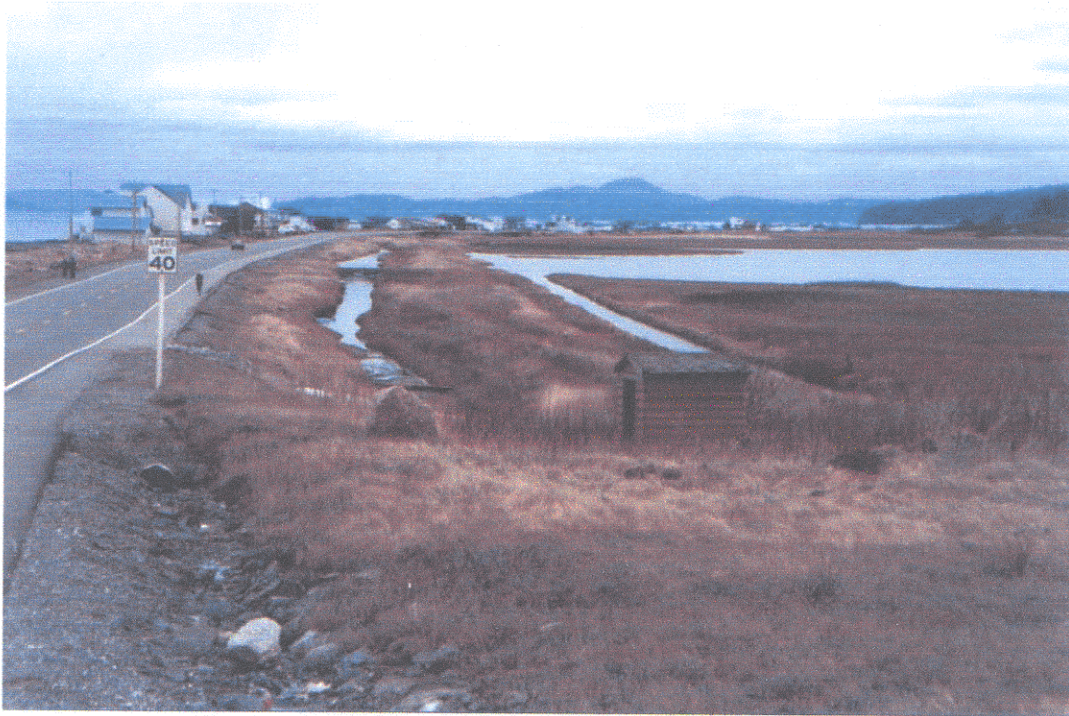
**Looking north along West Beach Road at west portion of marsh.**

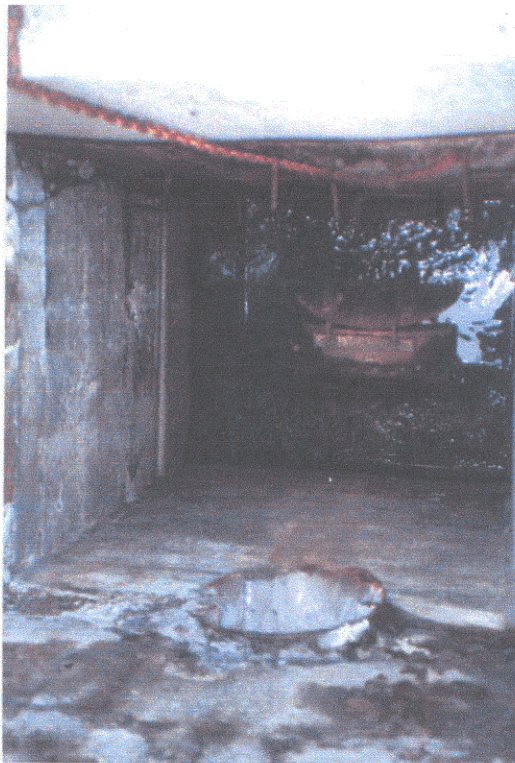
**Tidegate at ebb tide – appears stuck open due to sediment deposition.**

- Acquire or gain conservation easements for those portions of marsh and riparian corridor not currently owned by Island County
- Remove culverts, tidegate and other drainage structures near the main wetland outlet

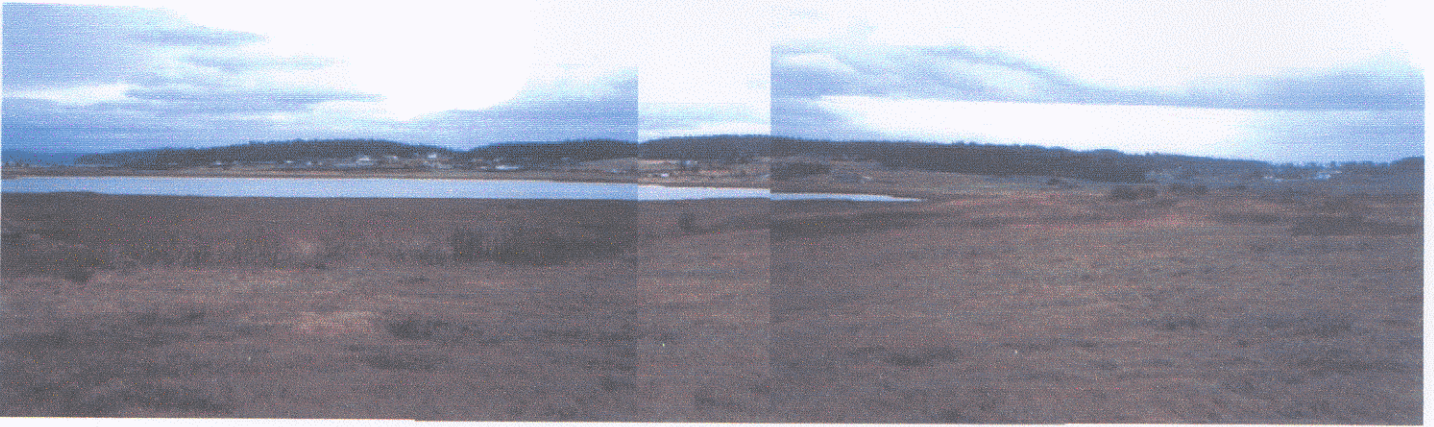
Looking north and northeast at marsh. Red-hued vegetation at lower elevations is *Scirpus maritimus*.

Stream enters system from right edge of photo.

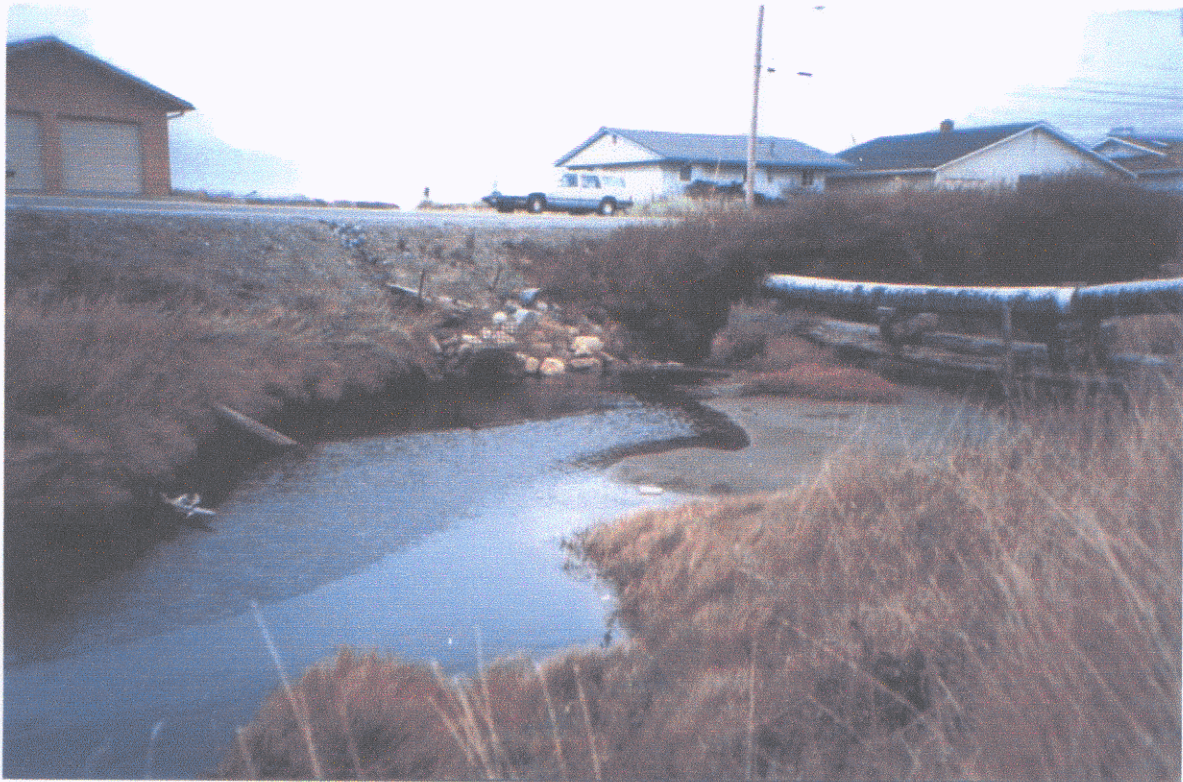
Outlet of system – 3-foot diameter pipe. Note grill of trash rack.

Suspended pipe in background not active. Tidegate is behind car on beach berm.

**Limiting Factors for Salmonid Use/Production:** Tidegate precludes salmonid access and limits saltwater exchange. Culvert from lake to saltwater is undersized and too long to allow good fish passage. Drainage ditches connected to tidegate currently not directly surface connected to open water area of wetland. Ditched stream flowing into lake lacks riparian vegetation - degraded spawning habitat. Could be usable habitat all the way up to the golf course (about 1.5 mile), but the stream needs restoration - re-construct channel to meander, and vegetate buffer. Could then potentially be used by chum, coho, and cutthroat.

- Restore open connection to saltwater by creating an open channel between lake and saltwater
- Install large box culvert or conspan under road, or bridge road
